R and **CENTER**
LABORATORY
TECHNICAL REPORT

NO. 12570

FAILURE ANALYSIS STUDIES OF T-142 TRACK PADS

JUN 1981

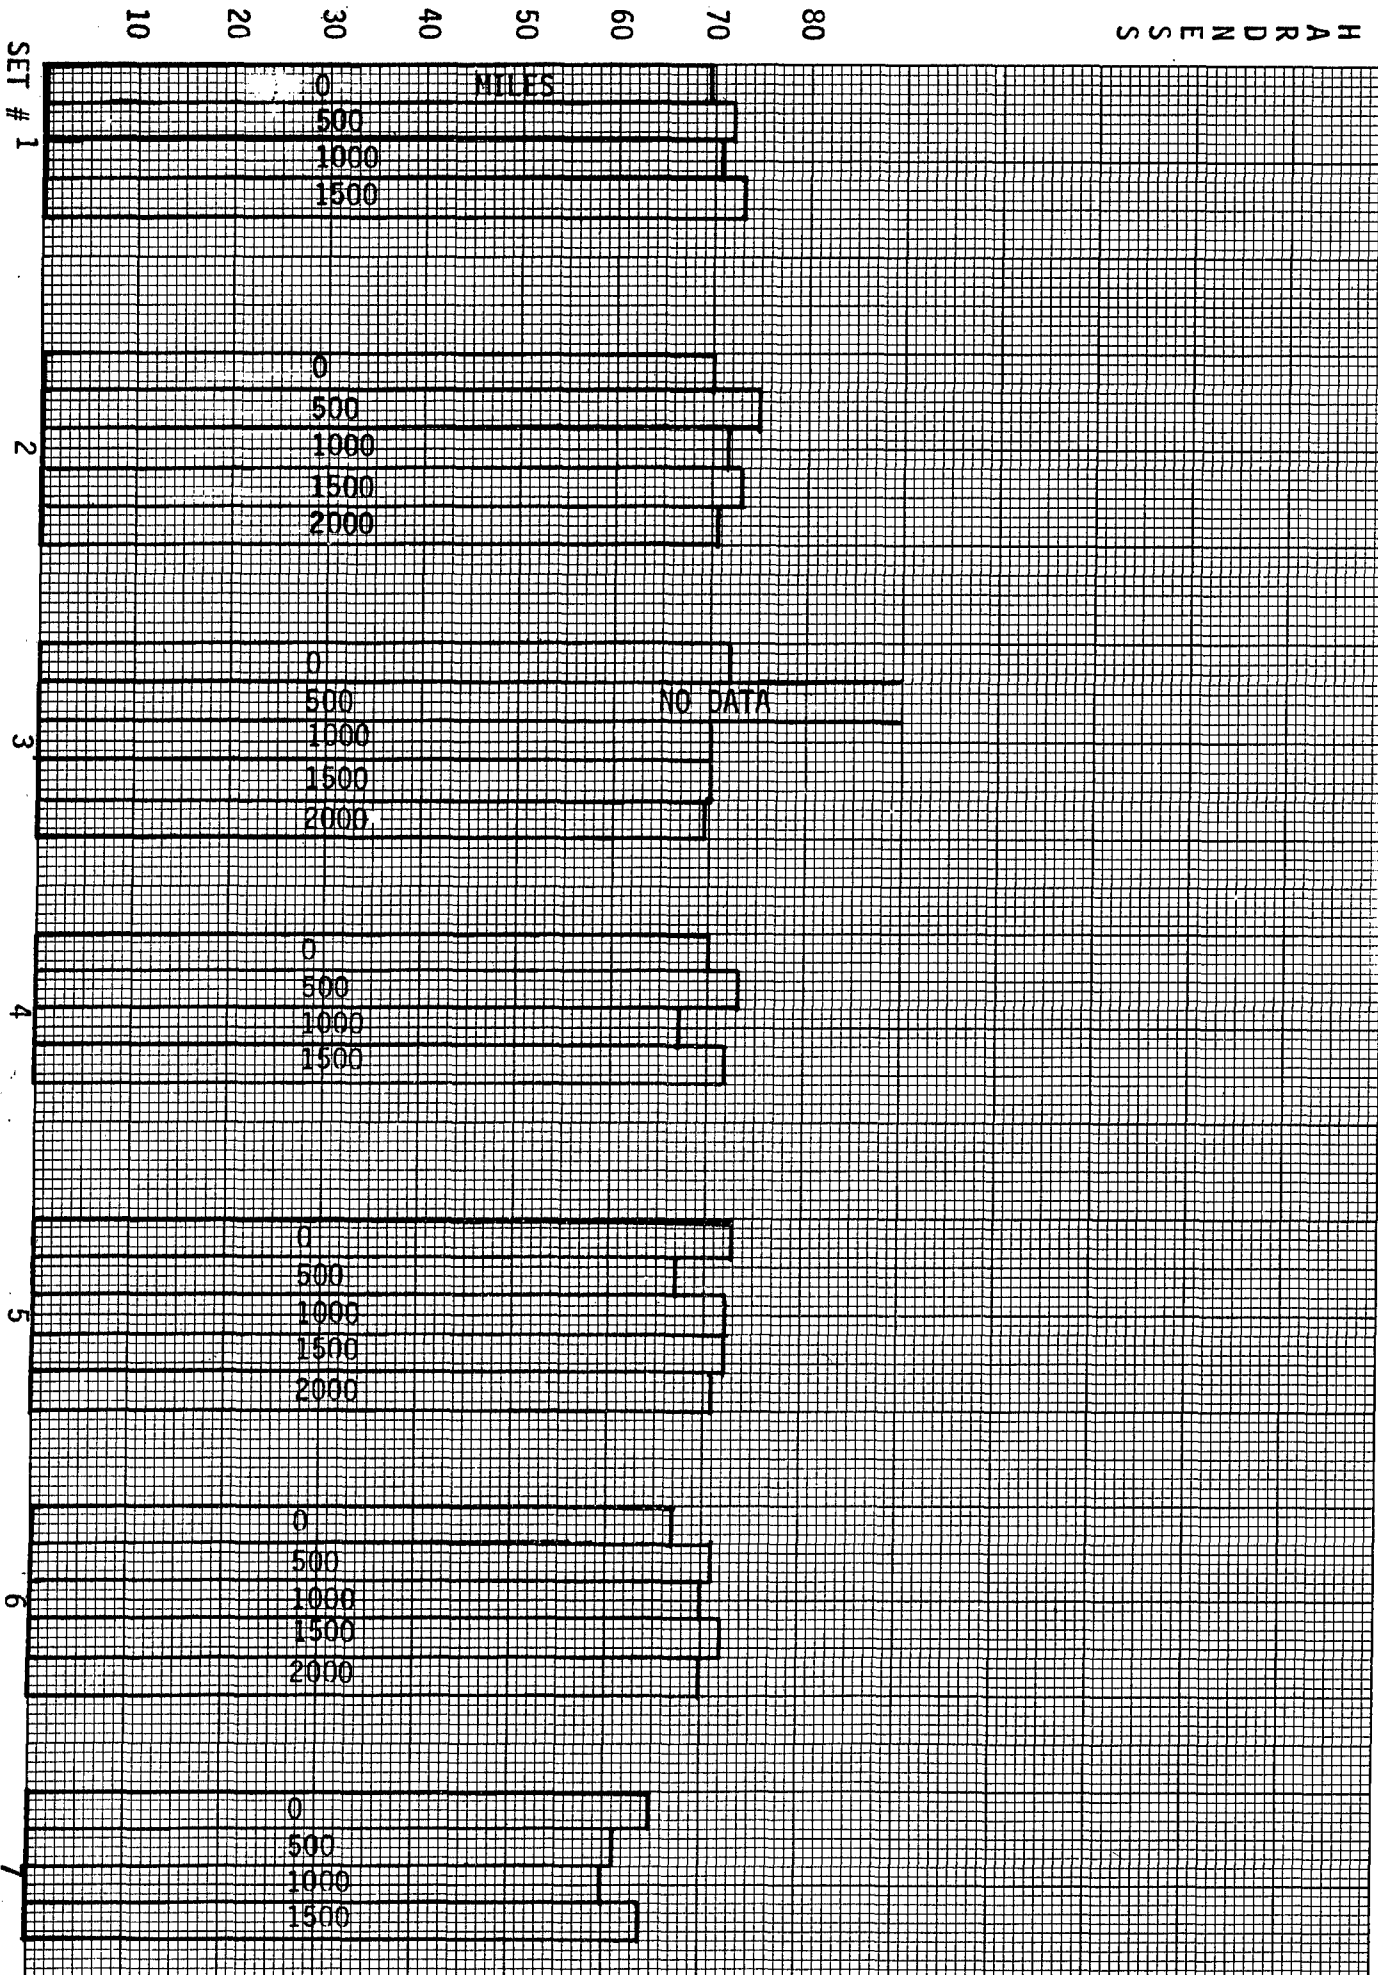
YUMA PAVED COURSE

"SHORE A" DUROMETER

PAD HARDNESS

a. Pad Rubber: Modulus, tensile, elongation, and hardness results are all graphed in the "Laboratory Results Graphs" portion of this report. These graphs show no correlation between these properties and field test performance. Toluene swelling (cross link density) tear resistance and hot tear resistance results are also graphed. These results indicate that a correlation may exist between these properties and field performance. Lower cross link density materials (higher toluene swelling) and materials with a higher tear resistance appear to perform better on vehicle testing. Only one data point is represented by these graphs, and further studies should be conducted before a definite conclusion can be drawn.

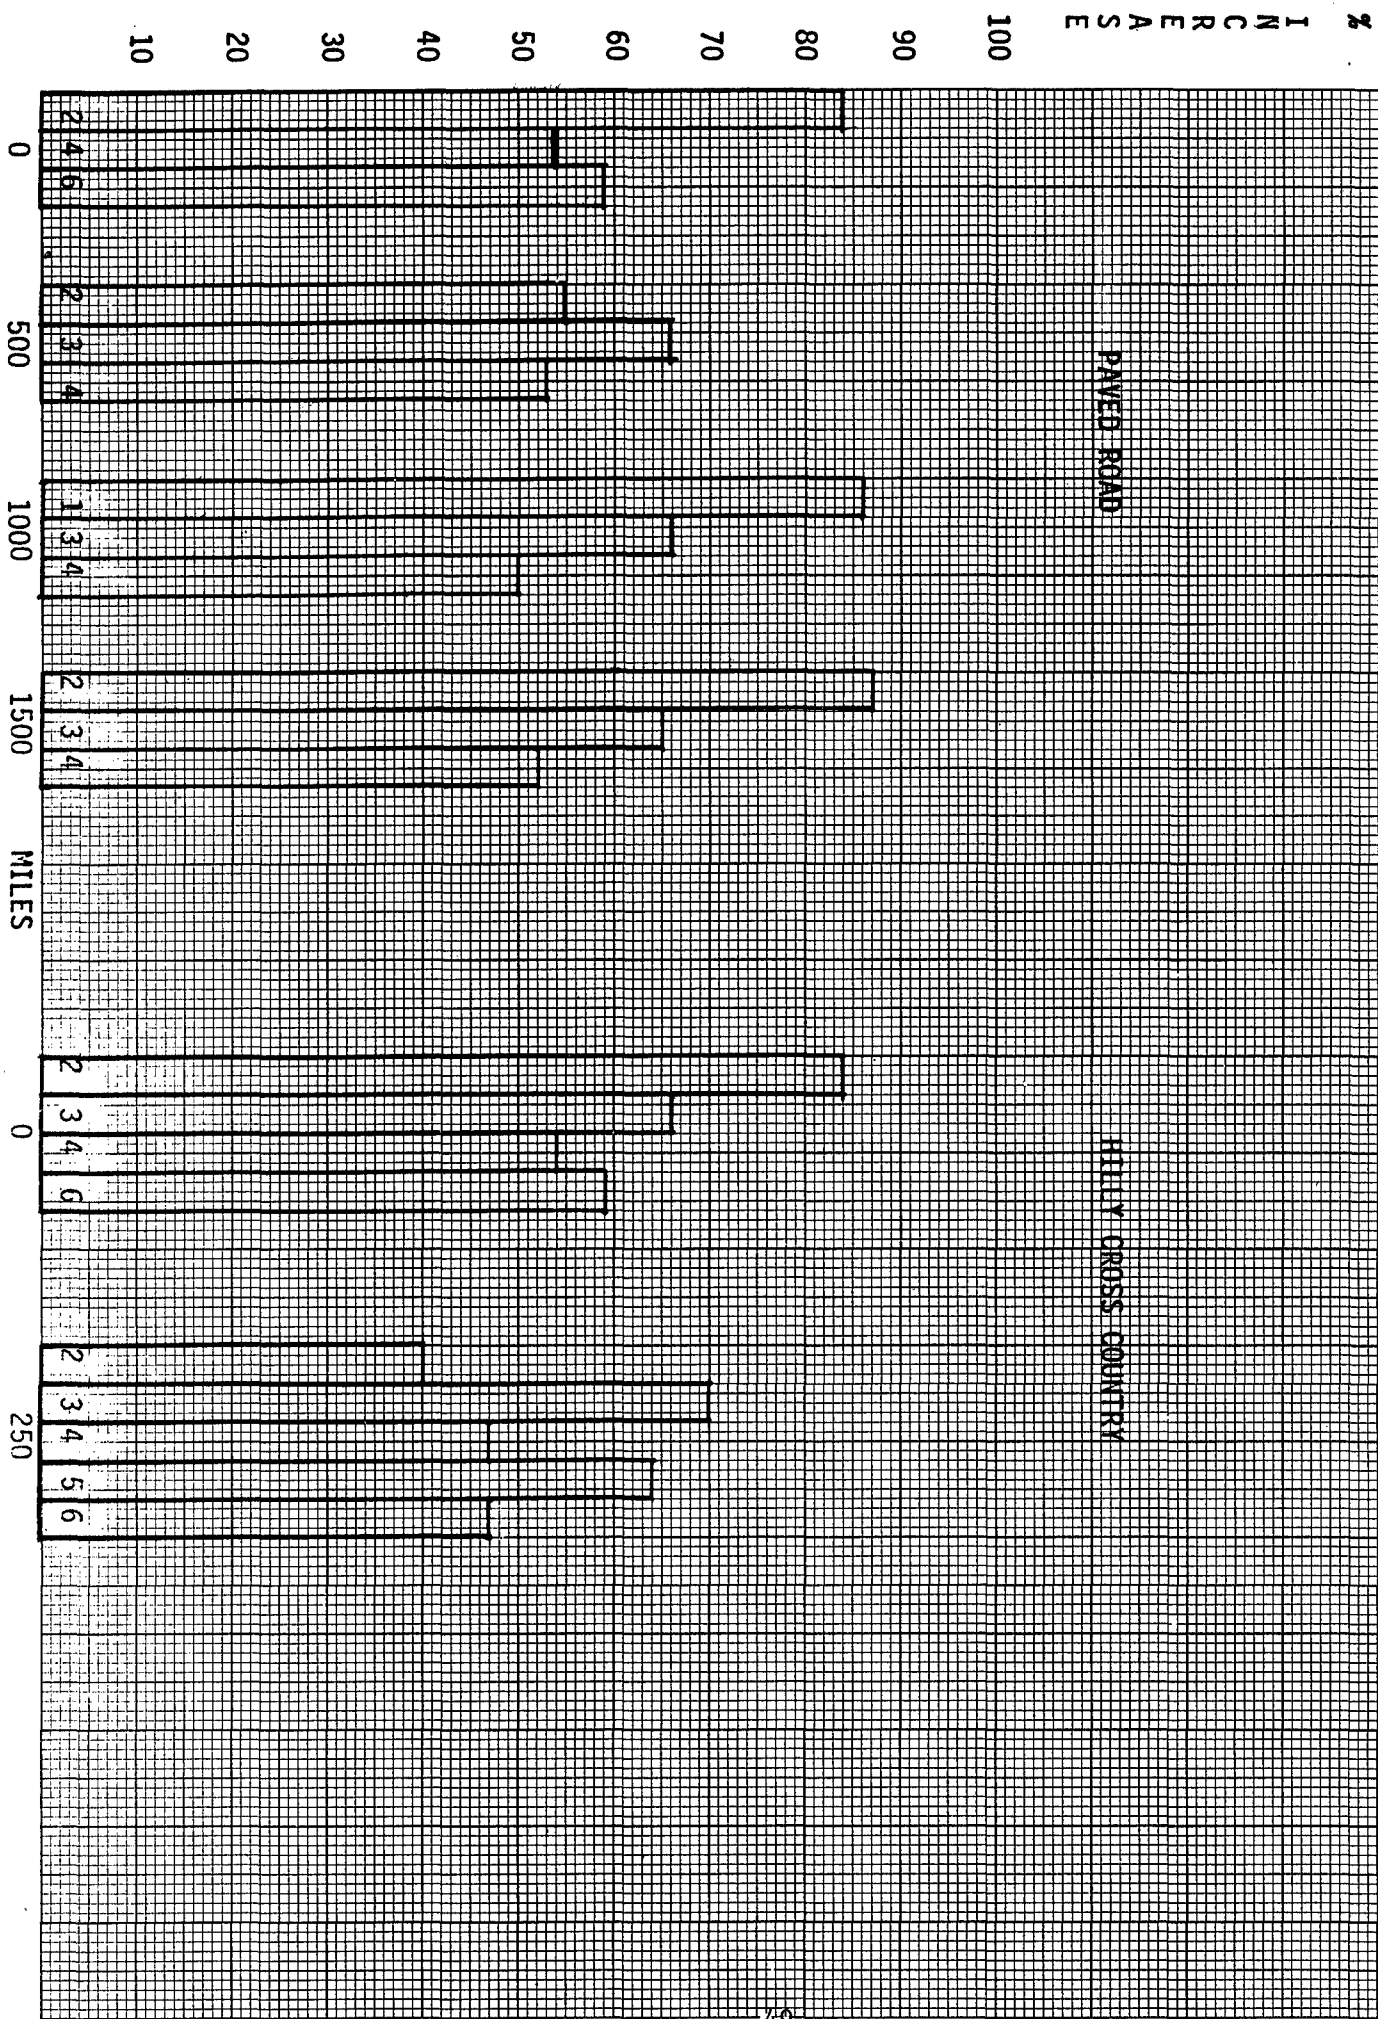
% INCREASE IN TOLUENE SWELLING

b. There are two tests, however, which may have a correlation to field performance. These tests are tear resistance and preservice cross link density. More trials should be conducted comparing these tests with vehicle performance in order to determine whether a correlation does in fact exist.

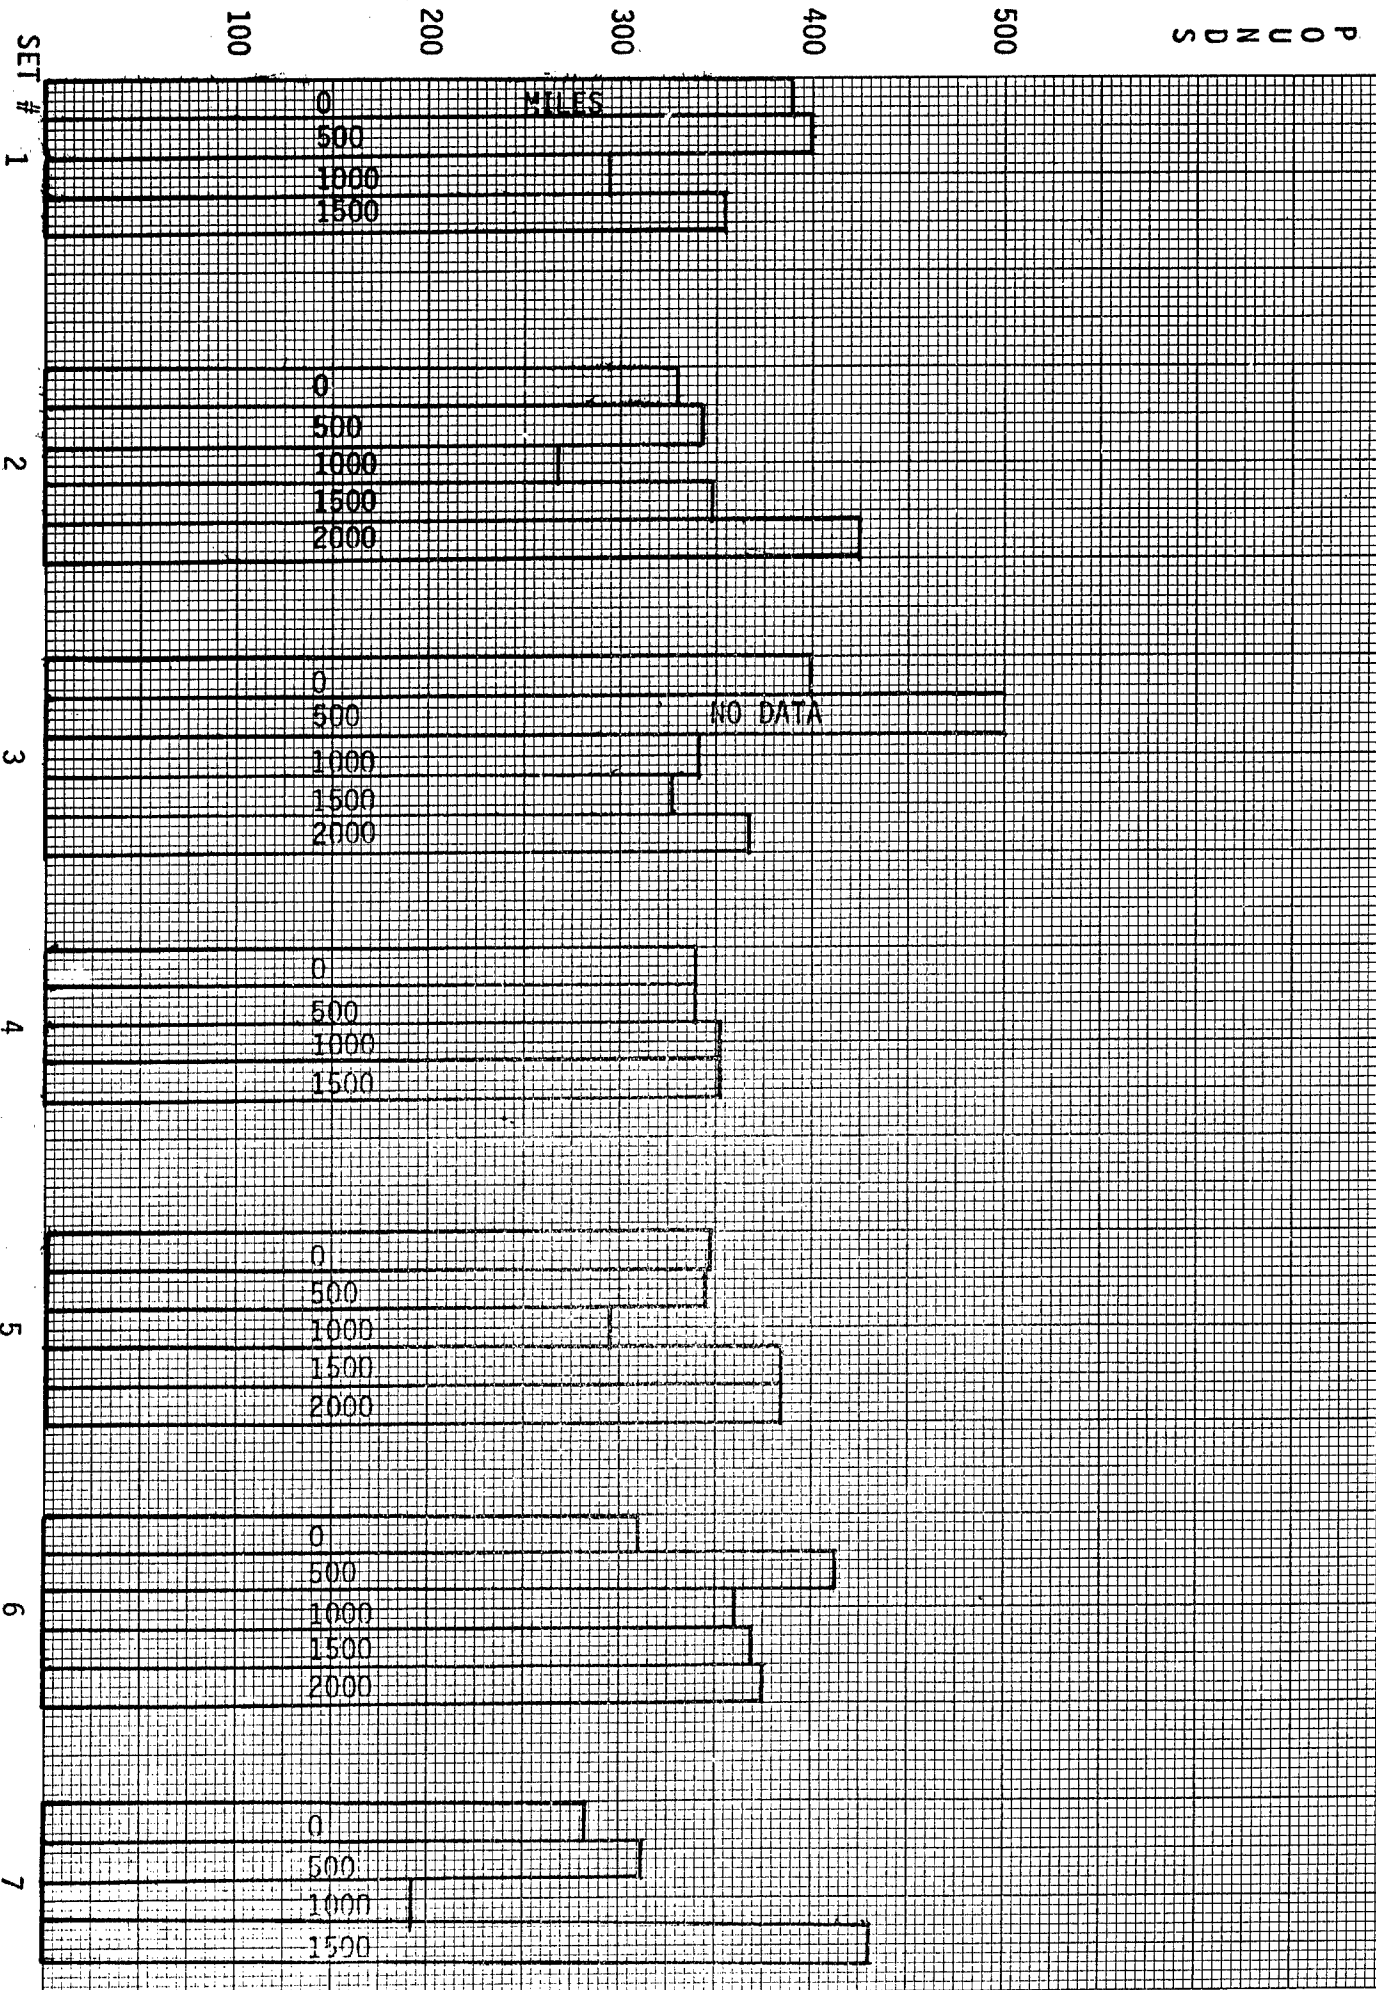
YUMA PAVED COURSE

TEAR RESISTANCE

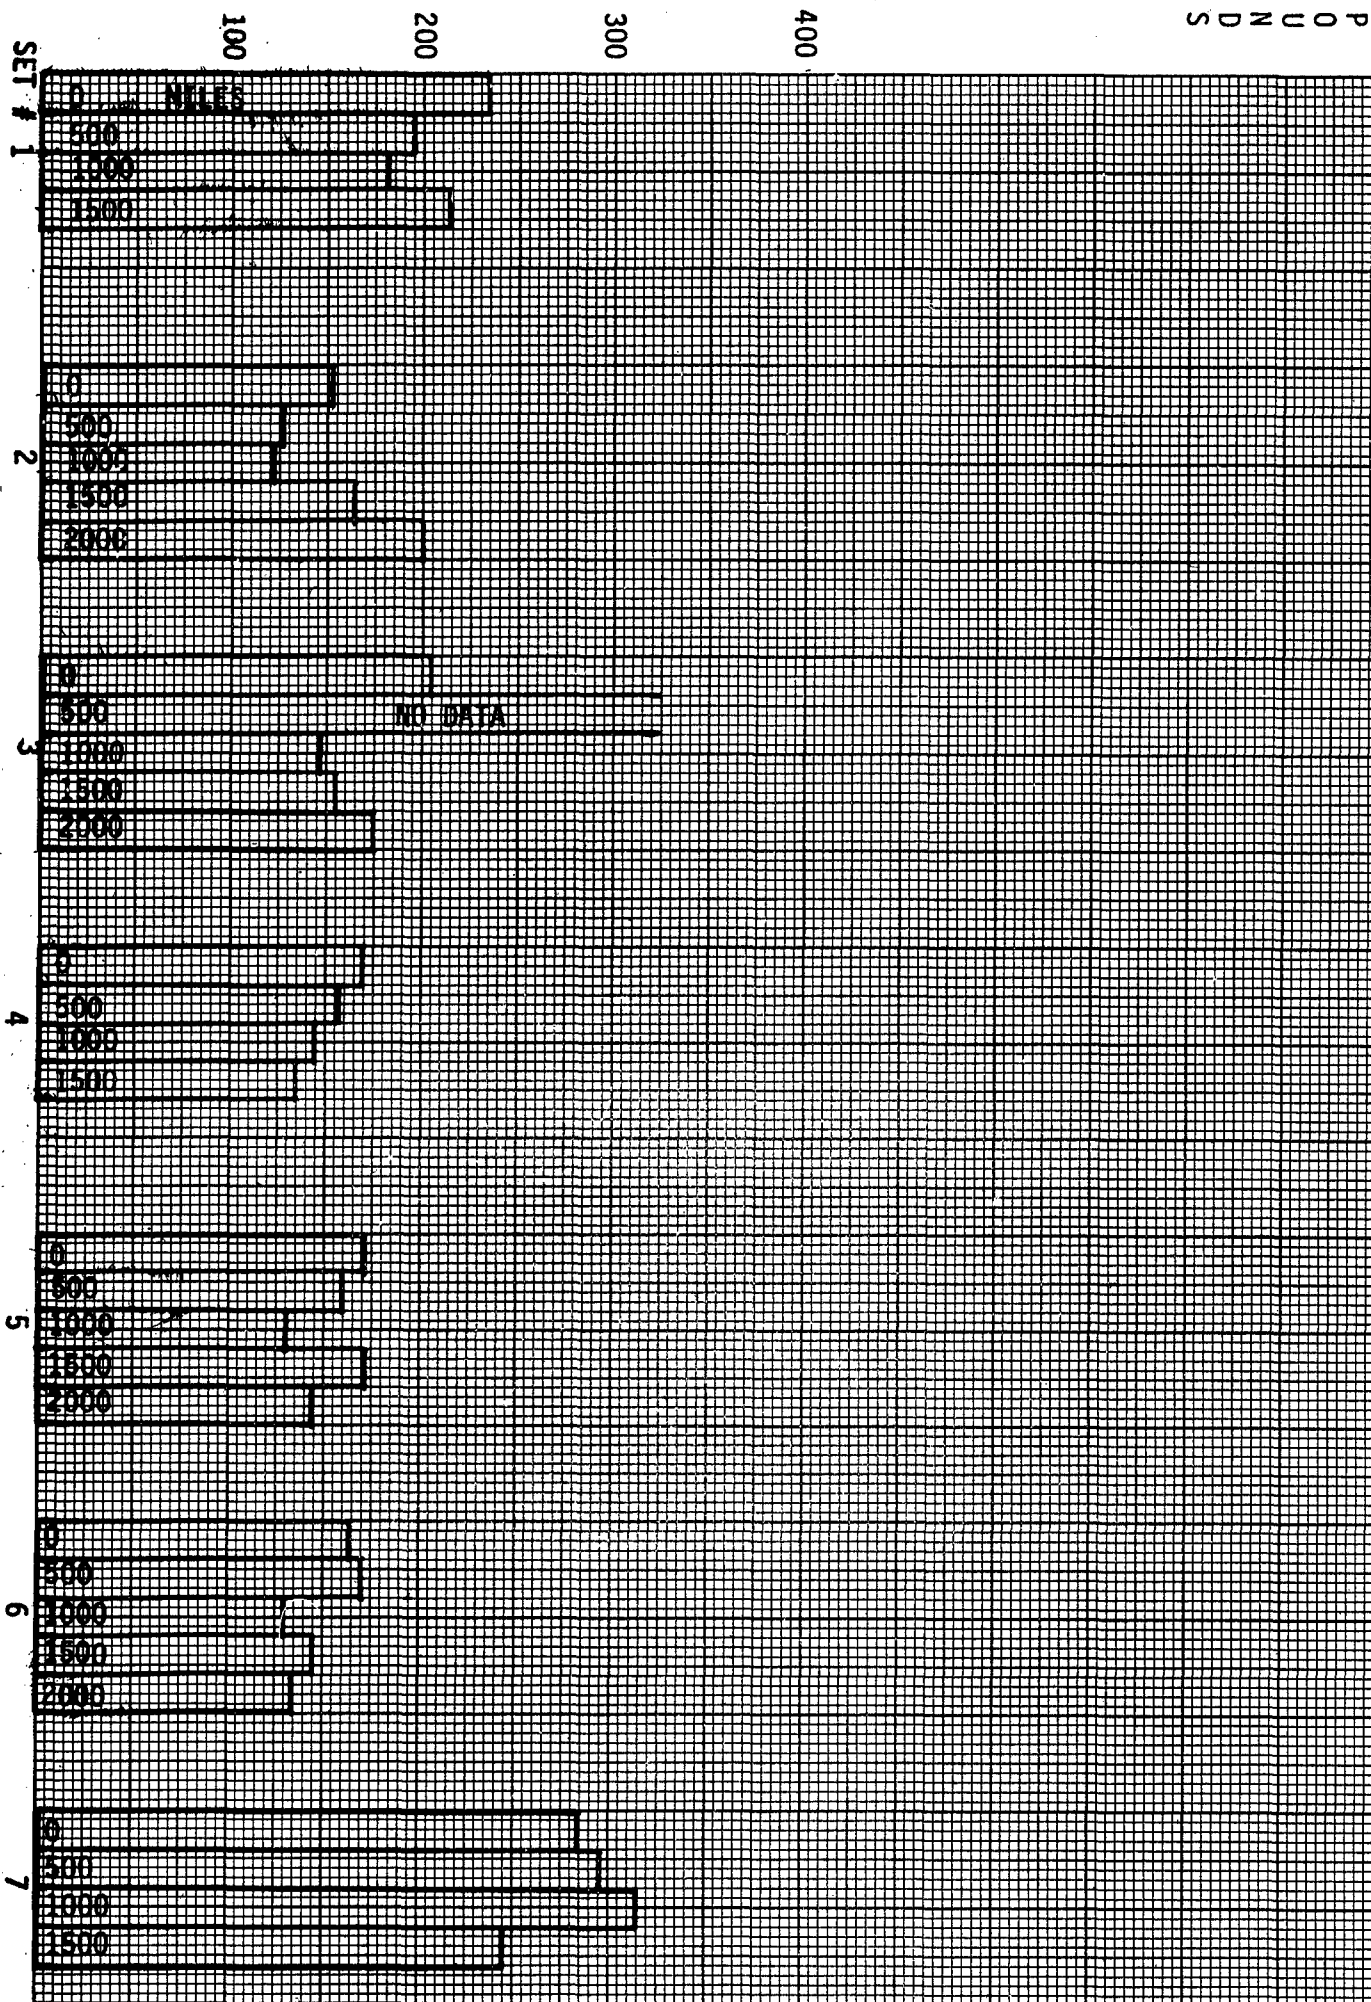
PAVED

HOT TEAR

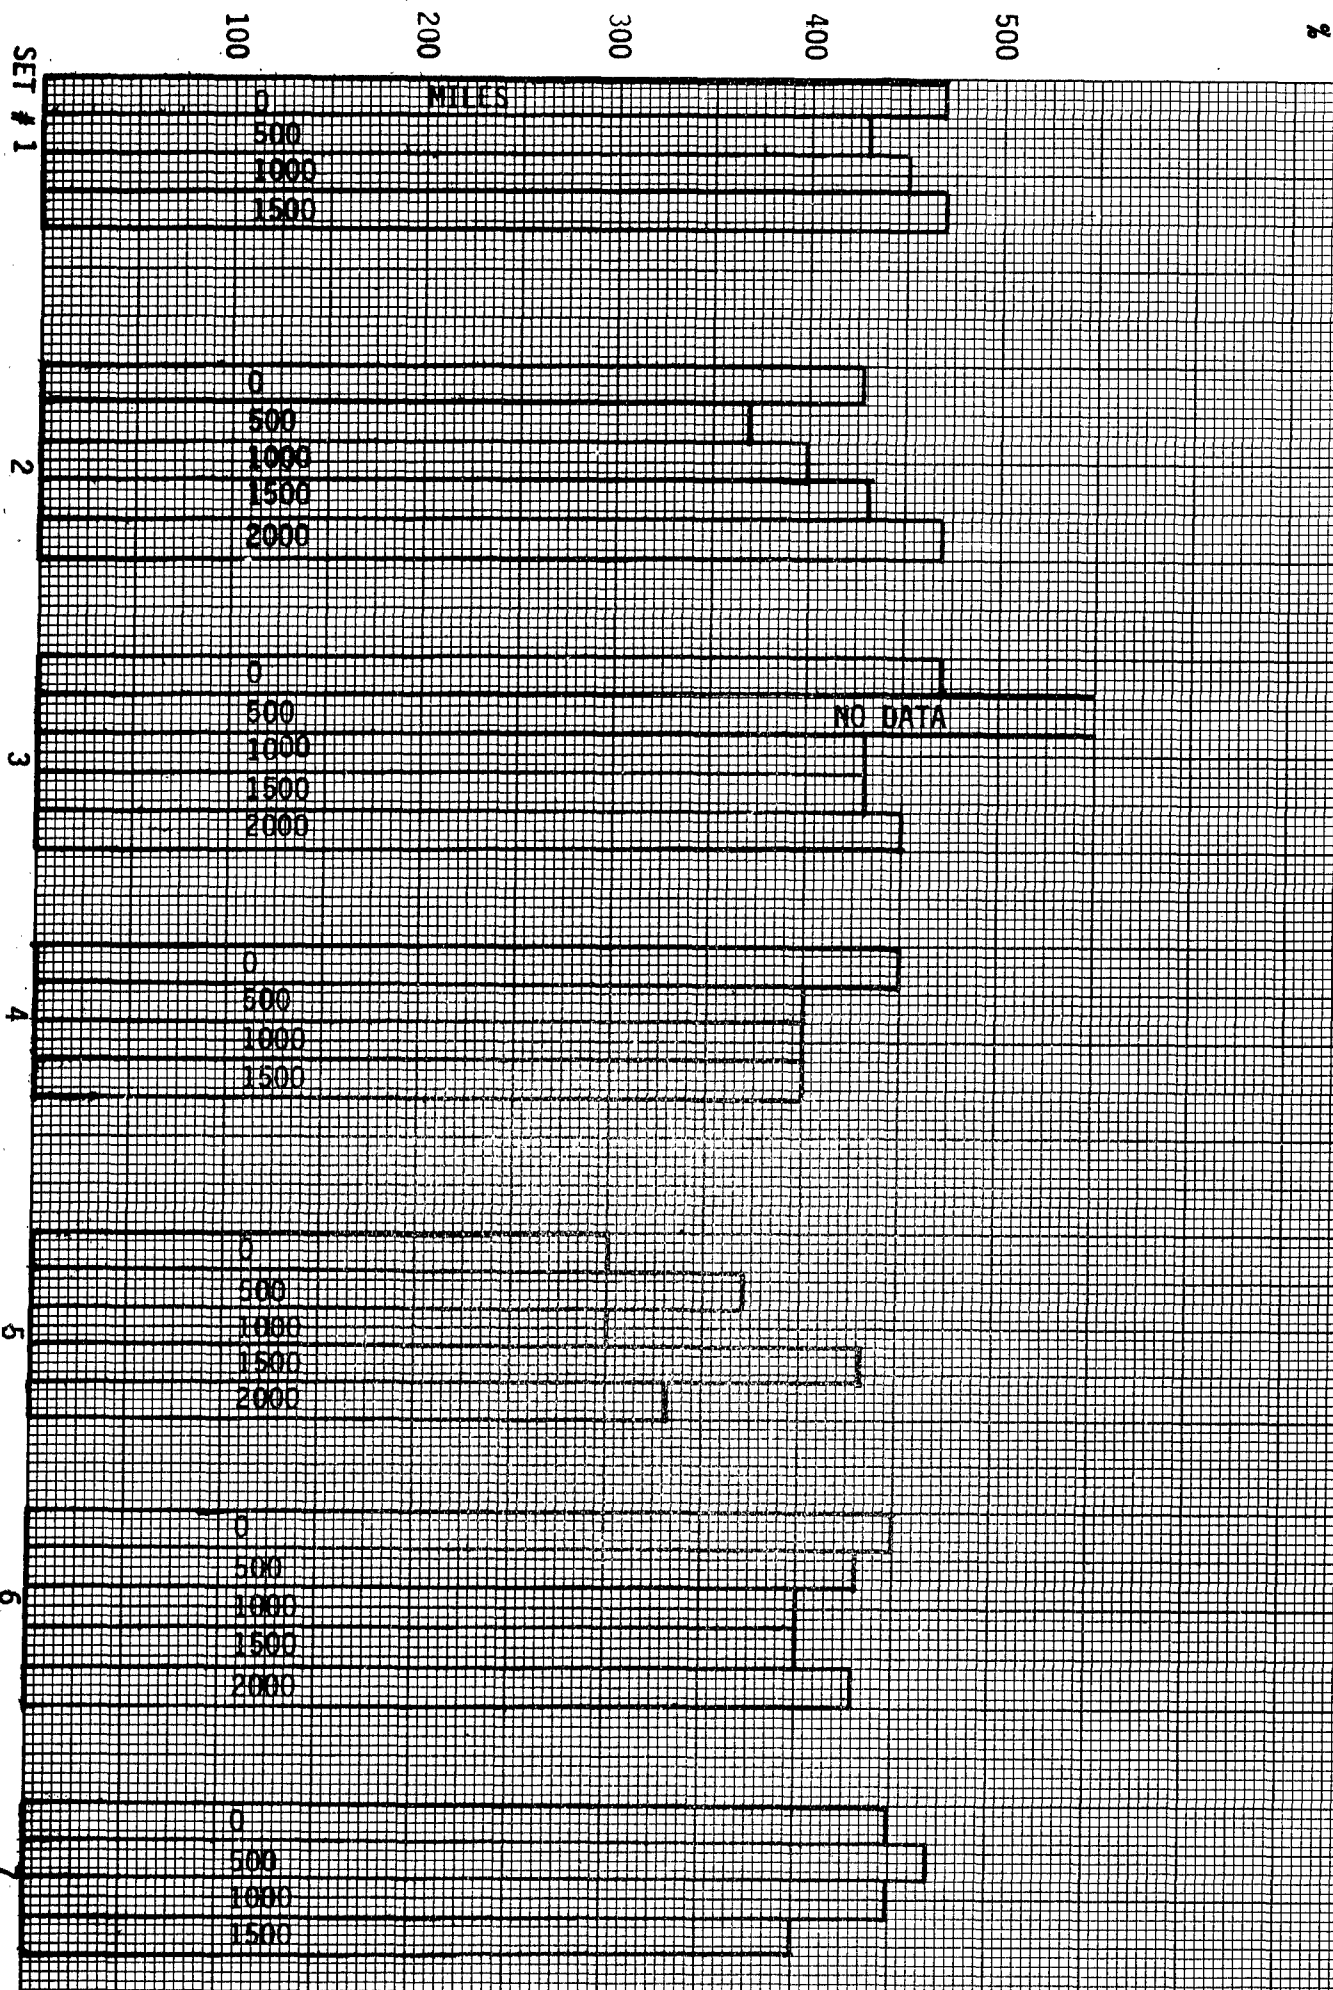
YUMA PAVED COURSE

ELONGATION
